Status of barrel acceptance tests

TRT meeting – Oct 2002

Pauline Gagnon – Indiana University

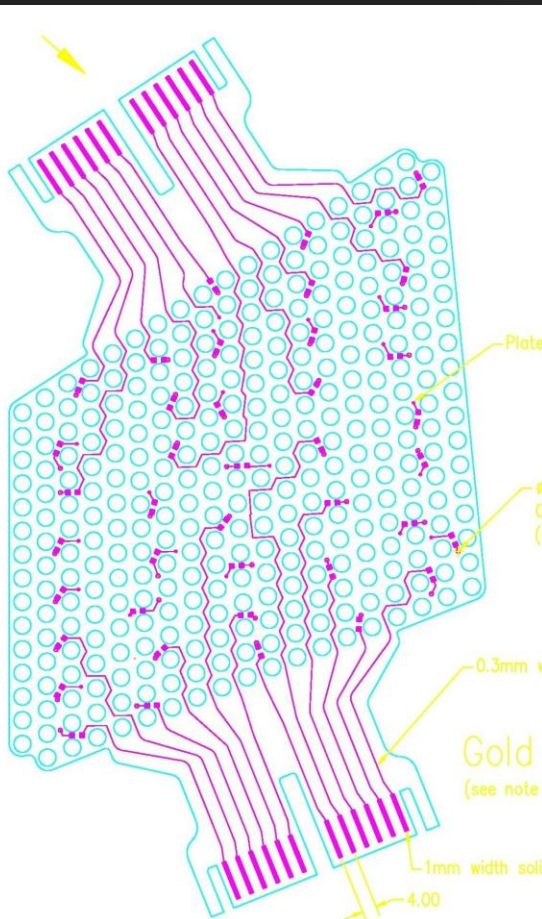
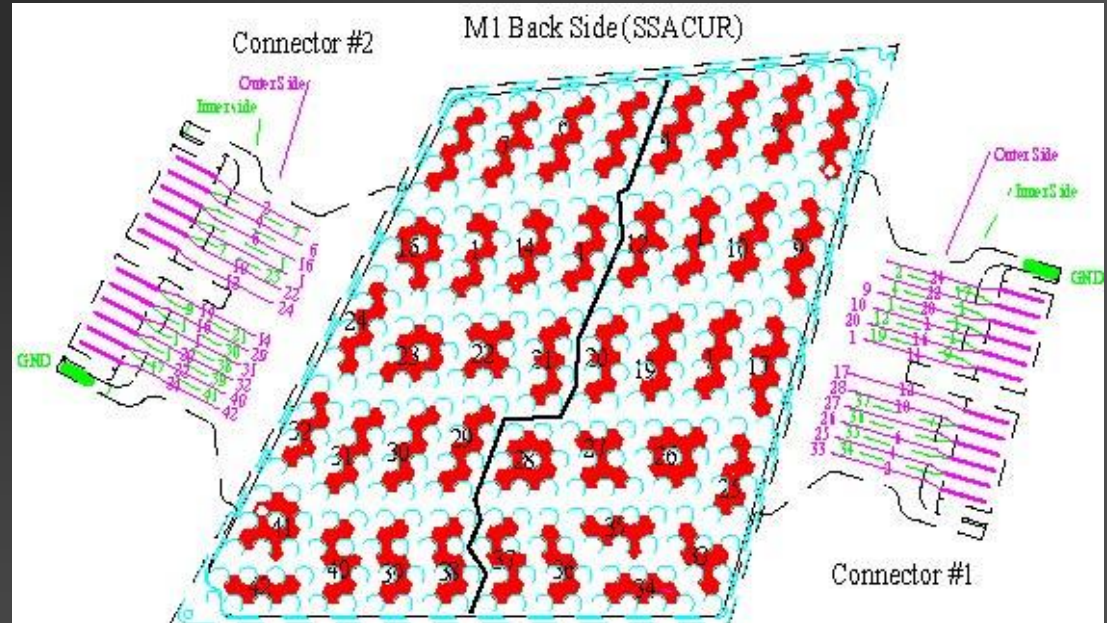
HV distribution on kapton sheet

2) HV system: 2 problems found

1. 1 HV channel supplying 3 HV pads could not hold voltage: could be a short inside fuse box – problem appeared after transportation from JINR to nuclear reactor. 24 straws without HV during irradiation
2. One broken wire in straw #142: wire broke when module was moved outside bldg 154 for floor cleaning

These problems seem unrelated to irradiation

- All HV connections on both ends ok
- Continuity test ok for all capacitors/straws

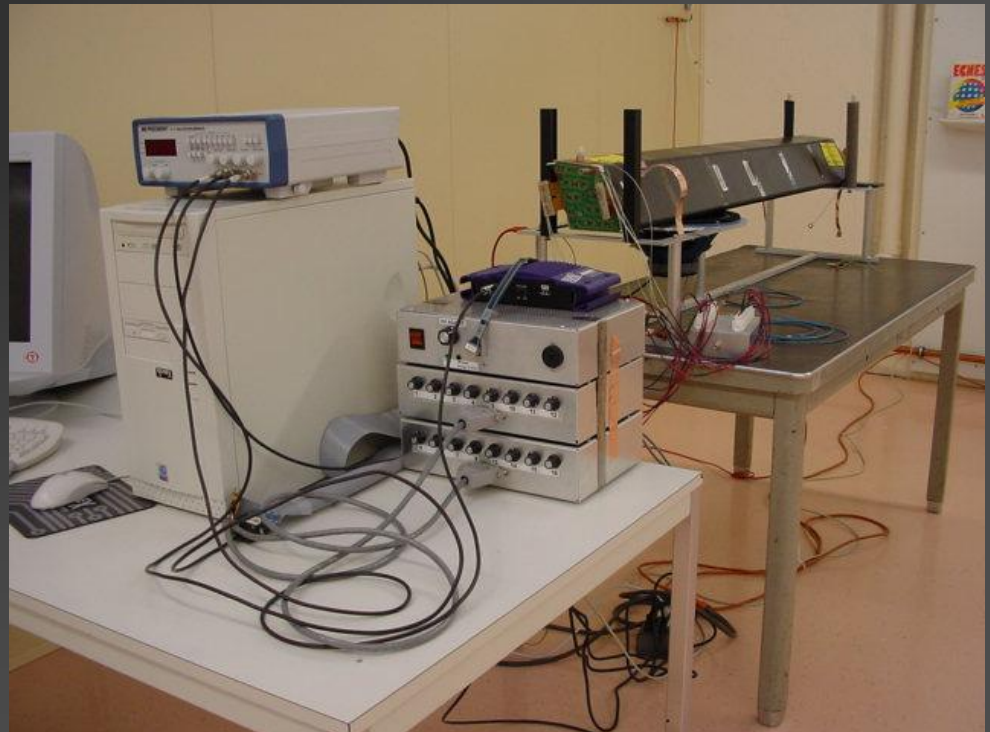
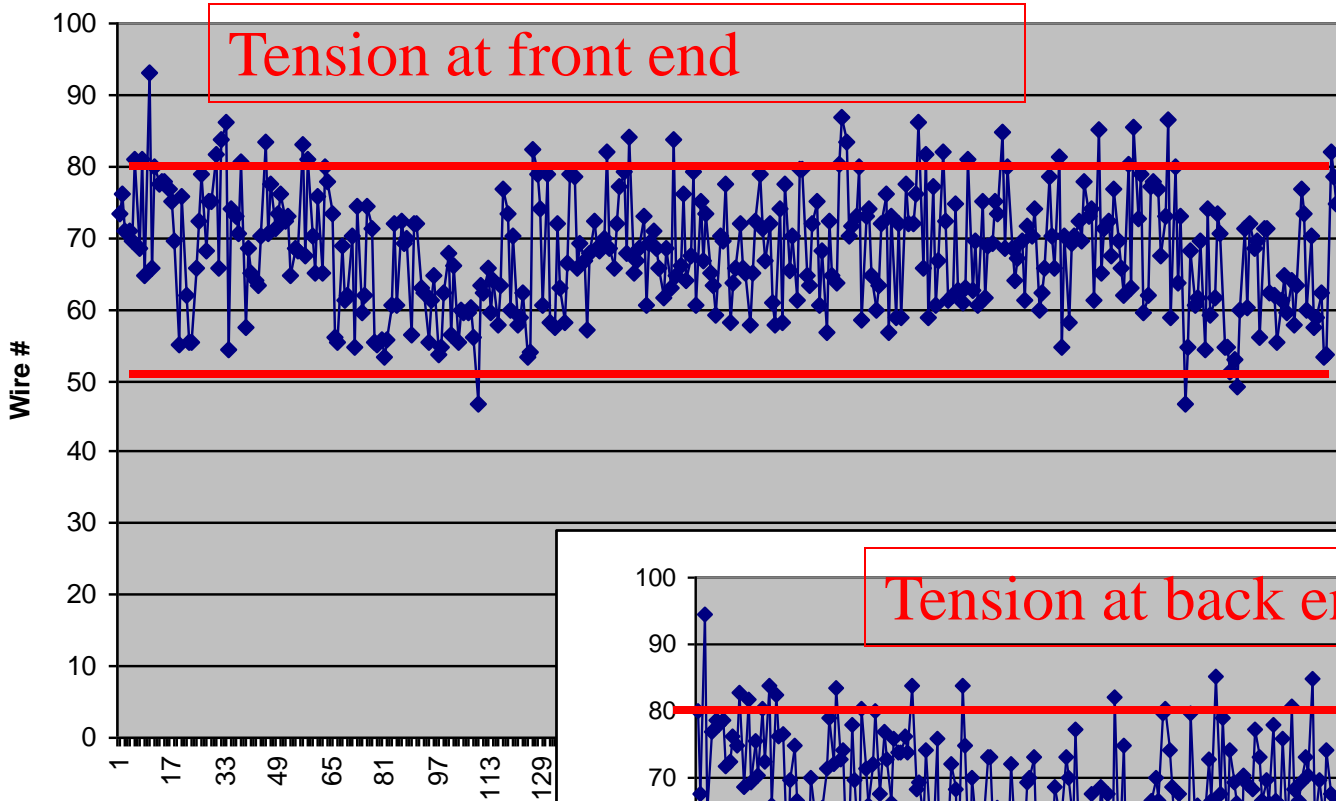
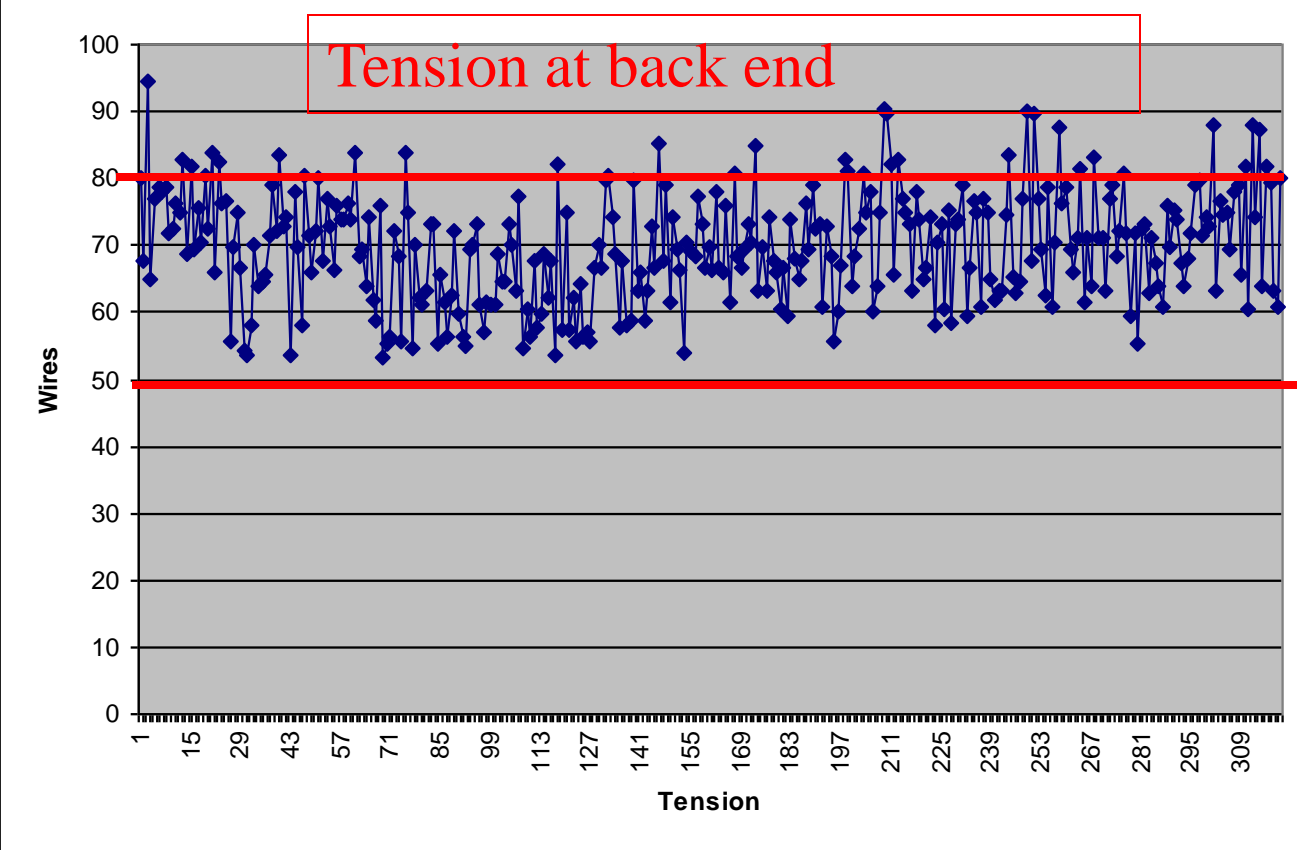
3) Wire tension test

- Both front and back ends tested
- No broken wires found
- Two wires may have slipped

Tension now versus Oct 00

F (Hz)	Oct 00	Feb 01	Oct 02
Front	μ : 146.0 σ : 9.5	μ : 145.3 σ : 8.4	μ : 149.3 σ : 9.0
Back		μ : 154.5 σ : 6.9	μ : 151.3 σ : 8.9

No systematic shift

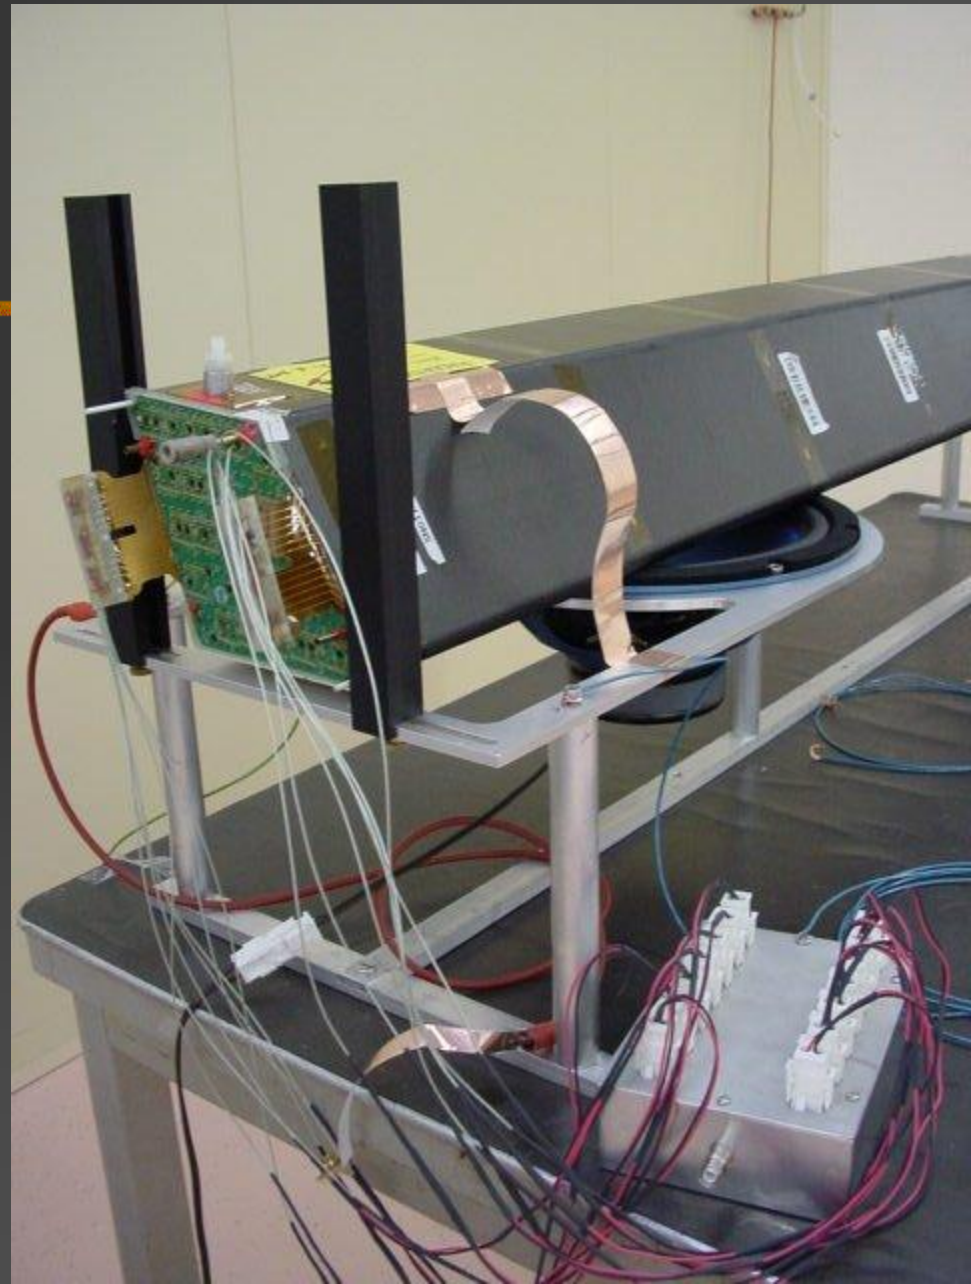
Fuse box connectors

- Things are progressing well and on schedule for the barrel acceptance tests
- Module 1.01 seems to have survived 10 times the LHC neutron flux without major problems. Full assessment to be completed.
- No HV problems found so far but fuse box connectors are very tricky to use
